DEPARTMENT OF TRANSPORTATION**DIVISION OF ENGINEERING SERVICES**

Quality Assurance and Source Inspection

Contract #: 04-0120F4Cty: SF/ALA Rte: 80 PM: 13.2/13.9File #: 69.28**WELDING INSPECTION REPORT****Resident Engineer:**Pursell, Gary**Address:** 333 Burma Road**City:** Oakland, CA 94607**Report No:** WIR-015123**Date Inspected:** 20-Jun-2010**Project Name:** SAS Superstructure**OSM Arrival Time:** 700**Prime Contractor:** American Bridge/Fluor Enterprises, a JV**OSM Departure Time:** 1900**Contractor:** Zhenhua Port Machinery Company, Ltd (ZPMC), Changxing Island **Location:** Shanghai,China**CWI Name:** Mr.Wu shi gao**CWI Present:** Yes No**Inspected CWI report:** Yes No N/A**Rod Oven in Use:** Yes No N/A**Electrode to specification:** Yes No N/A**Weld Procedures Followed:** Yes No N/A**Qualified Welders:** Yes No N/A**Verified Joint Fit-up:** Yes No N/A**Approved Drawings:** Yes No N/A**Approved WPS:** Yes No N/A**Delayed / Cancelled:** Yes No N/A**Bridge No:** 34-0006**Component:** OBG**Summary of Items Observed:**

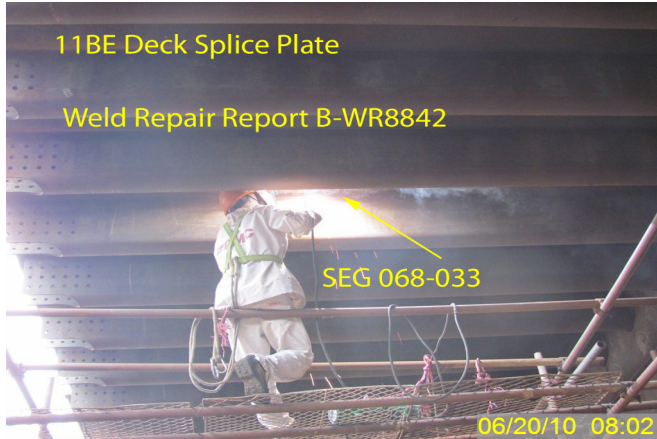
SMAW Welding of weld joint no: SEG 068-033 located on 11BE Deck Splice Plate. Welder is identified as 200113. ZPMC CWI is identified as Mr.Wu Shi Gao. Welding was been performed against Weld Repair Report B-WR8842 and UT report number-B787-UT-9693.The welding variables recorded by QC appeared to comply

with the WPS-345-SMAW-4G(4F)-Repair. Please see the attached picture.

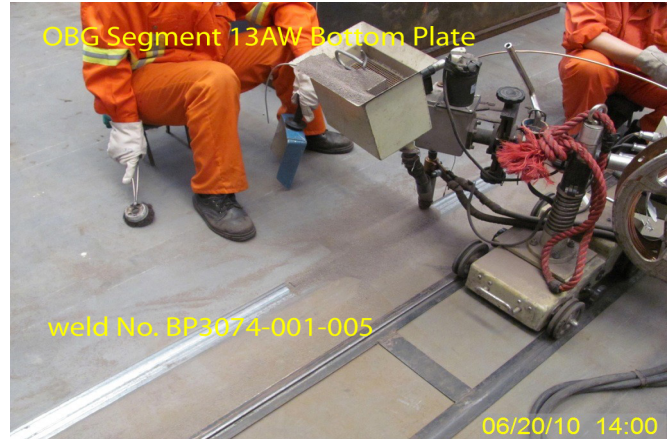
SAW in the 1G position for the OBG Segment 13AW bottom Plate, weld No. BP3074-001-005. The welder is identified as #045265. ZPMC QC is identified as Mr. Xia Chun Hui. The welding variables recorded by QC appear to comply with WPS-B-T-2221-B-U3c-S-2. Please see the attached picture.
